Inspection Report

Lower 80 Park Trail
Cincinnati Oh 45000

SAFEGUARD BUILDING INSPECTIONS, LLC

Date: 8/3/2015	Time: 08:30 AM	Report ID: 8-3-15 Lower 80 Park Trail
Property: Lower 80 Park Trail Cincinnati Oh 45000	Customer: Mr. Redtail Hawk	Real Estate Professional:

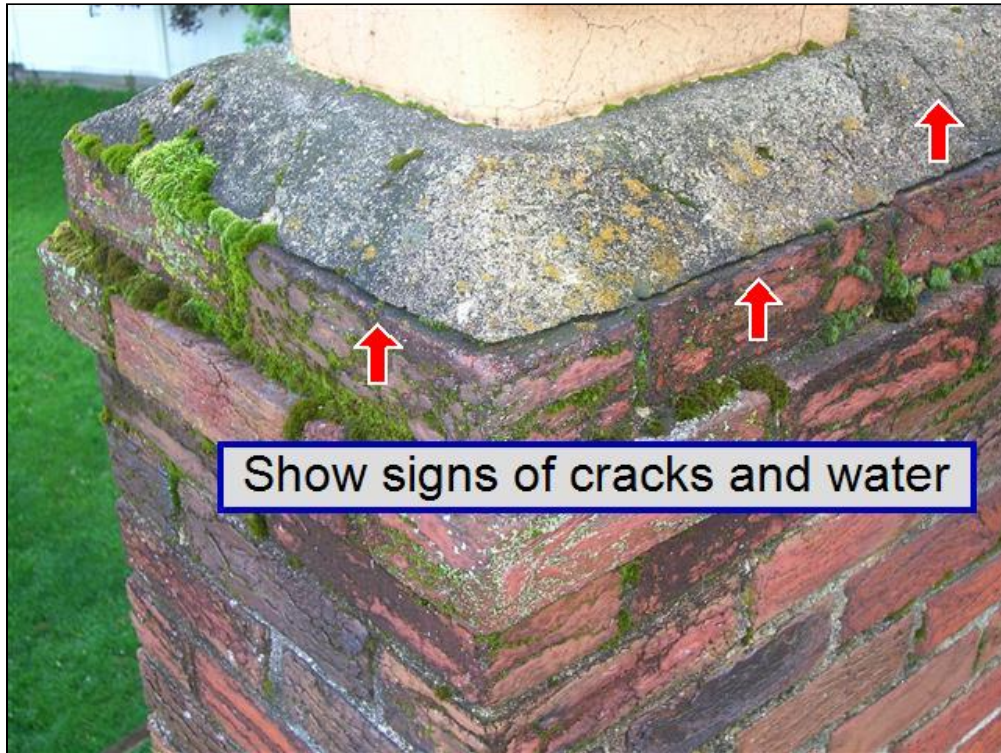
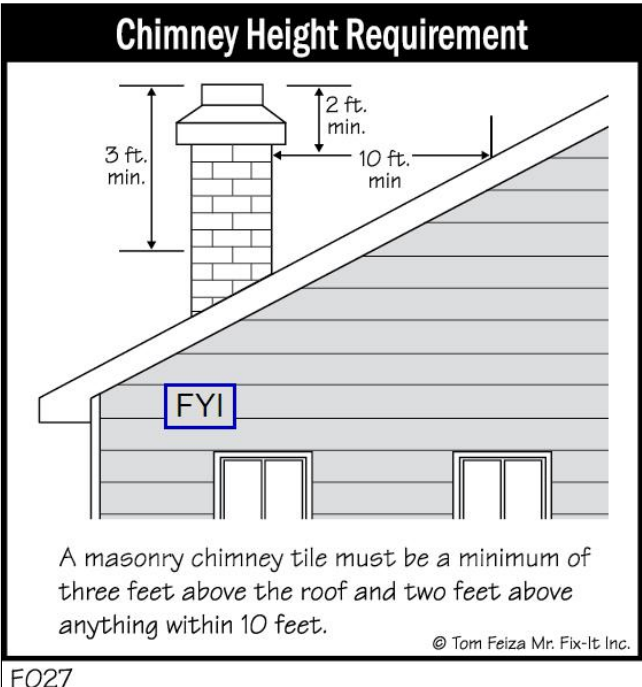
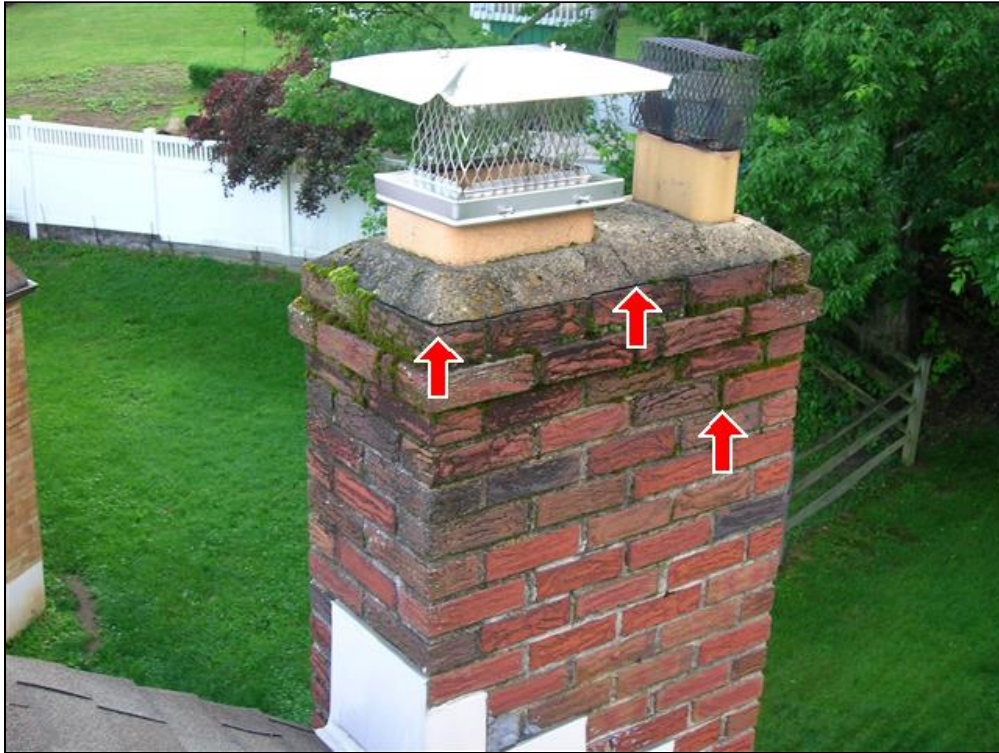
1.2 Item 1(Picture)

The plumbing vent on the back side of the roof is in need of repair. The chimney show signs of needed repair due to cracks in the cap and cracks in the brick. Recommend a masonry contractor review and inspect for repair needs.

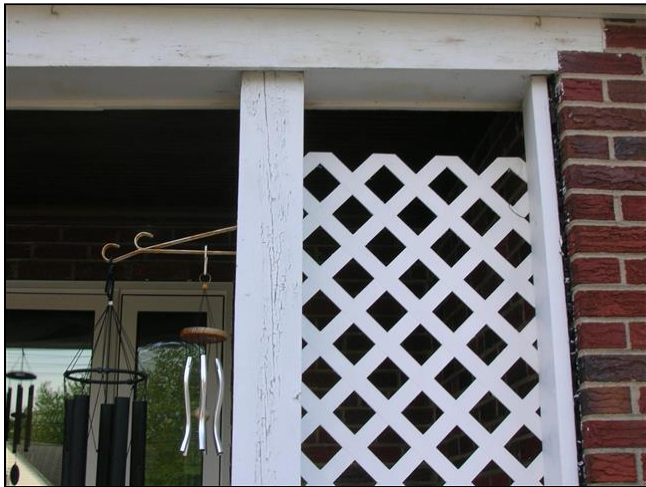
2.0 Item 1(Picture)

The trim of the home needs to be painted to keep any moisture out and help protect the home. The vinyl siding on the home is bleeding down onto the existing brick. Recommend that the siding and brick be cleaned.

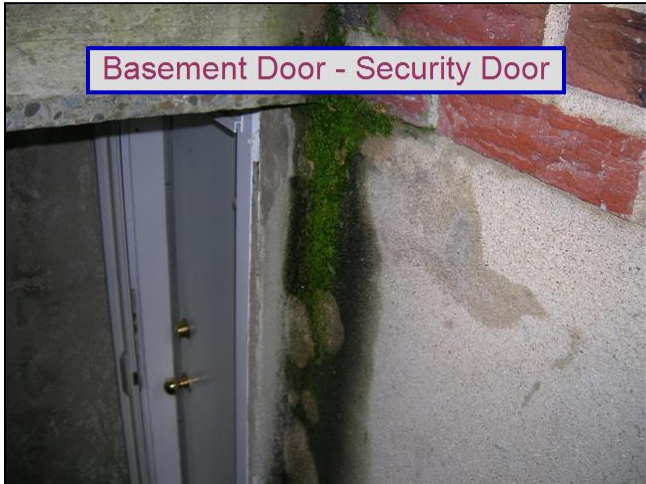
2.1 Item 1(Picture)

Front door is in good shape but could use new weather stripping. Rear entrance door is a solid security door but shows some signs of water intrusion. New weather stripping would also help here.

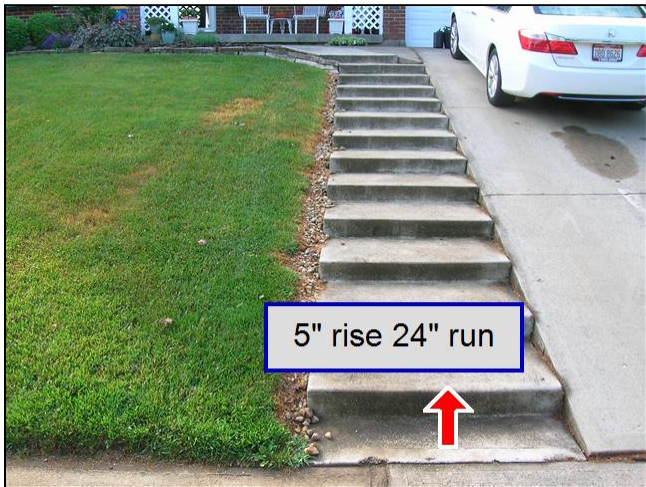
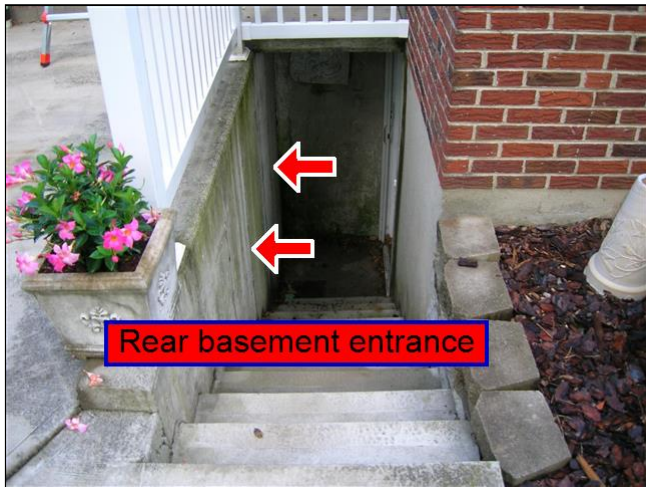
2.3 Item 1(Picture)

Front stairs from street to home have a short rise and long run. 5" rise and 24" run. Recommend hand rail be installed.

Rear entrance to home show signs of green algae and moisture on the concrete walls. Recommend that this area be cleaned.

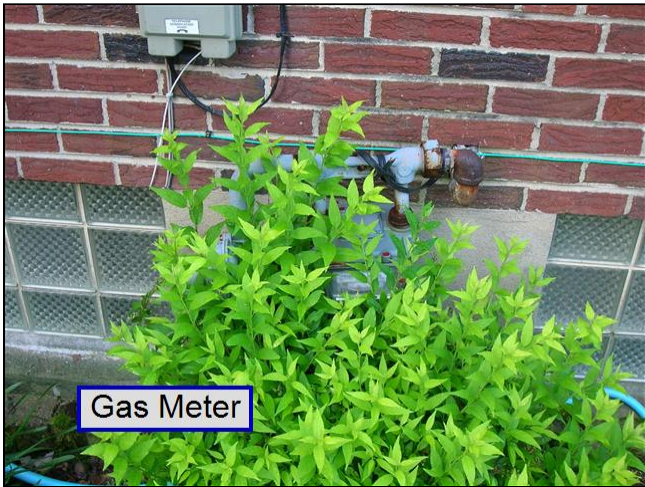
2.4 Item 1(Picture)

Mulch should be pulled away from the home. Vegetation has been well maintained. The vegetation around the gas meter needs to be cut away for better access. Driveway for the home is in good shape but the sidewalk is in need of replacement as desired.(See picture with box.)

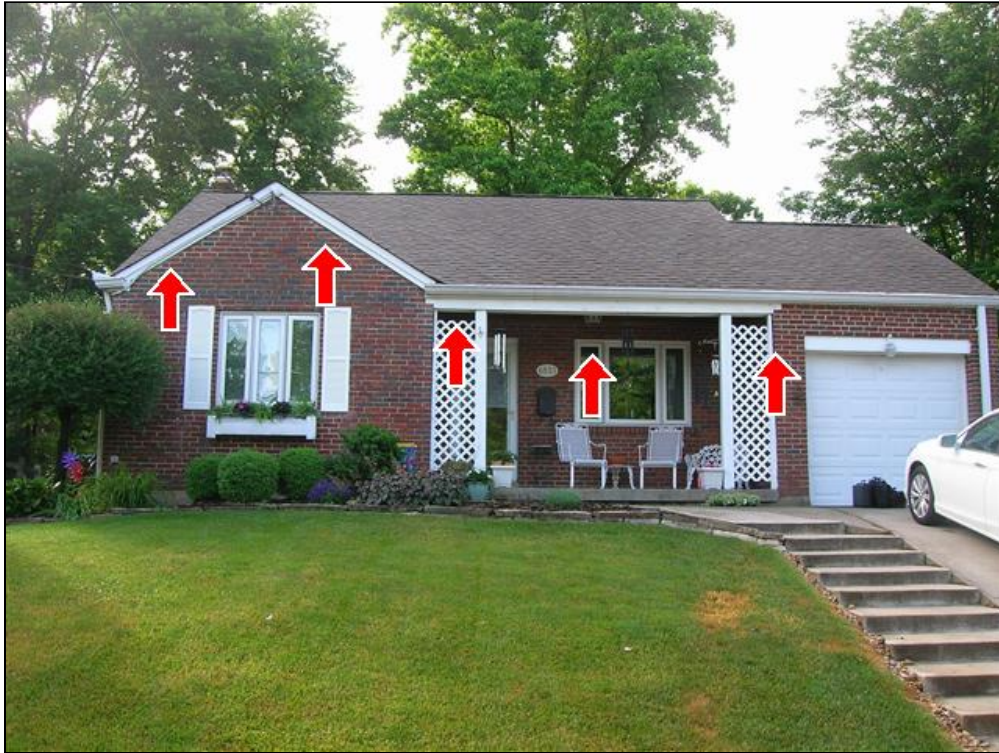
2.5 Item 1(Picture)

Exterior wood needs to be painted

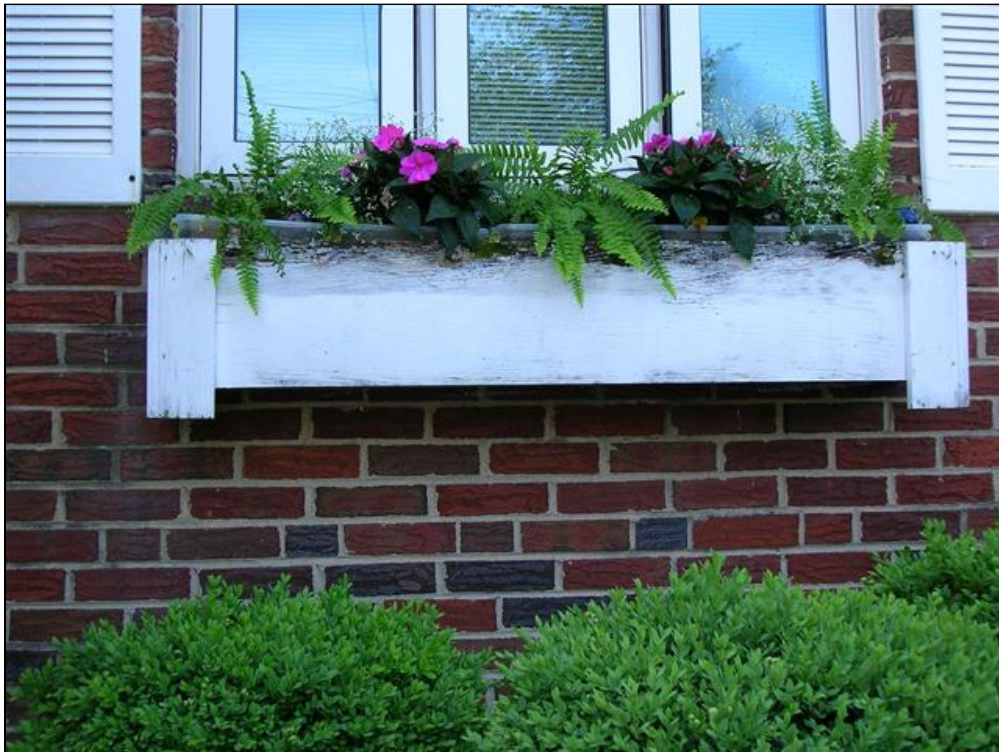
2.6 Item 1(Picture)

FYI: Flower Box needs to be replaced.

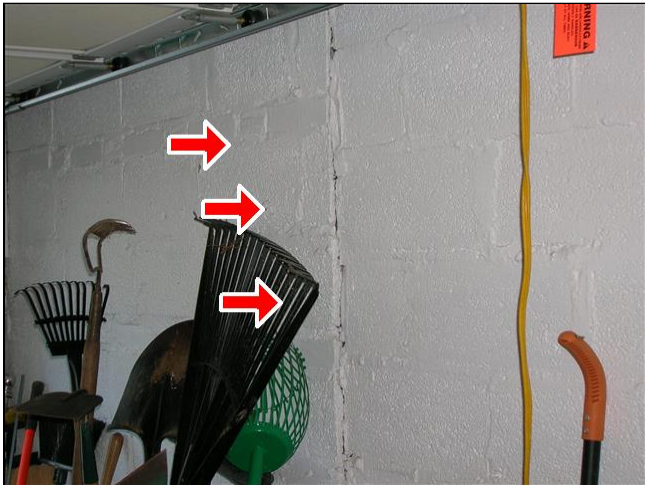
3.1 Item 1(Picture)

There are some cracks in the garage walls. Recommend a qualified masonry contractor repair as needed.

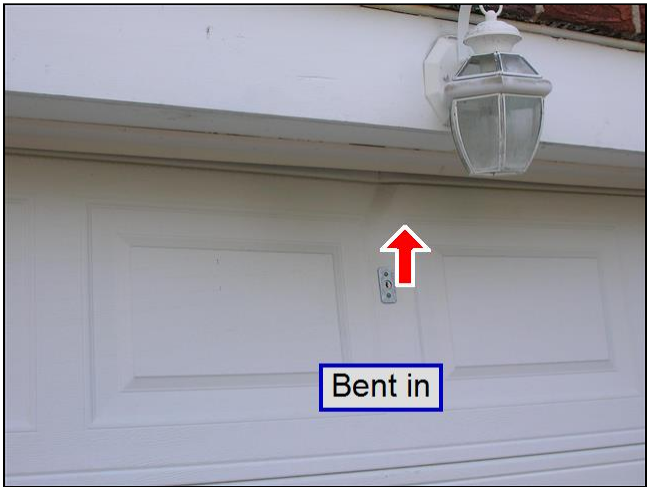
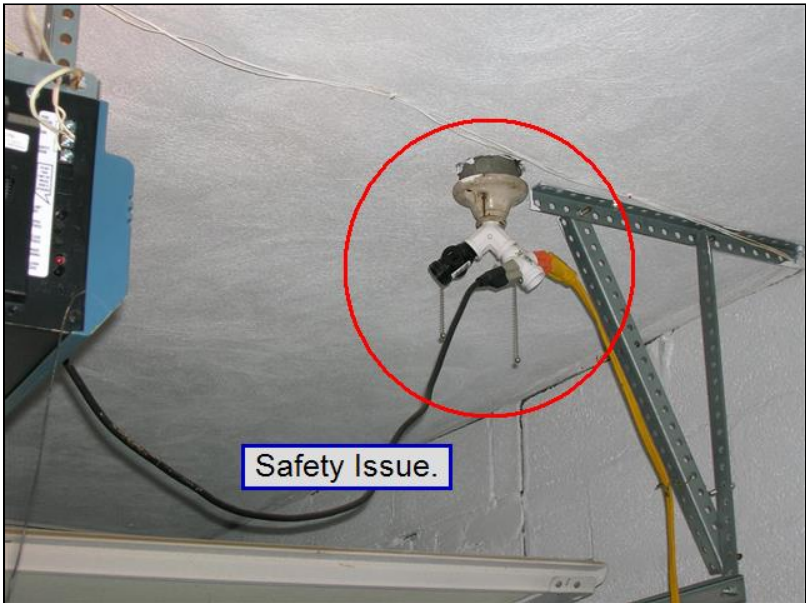
3.3 Item 1(Picture)

Garage Door is bent. Recommend qualified contractor repair the door and the electrical issue should be addressed also.

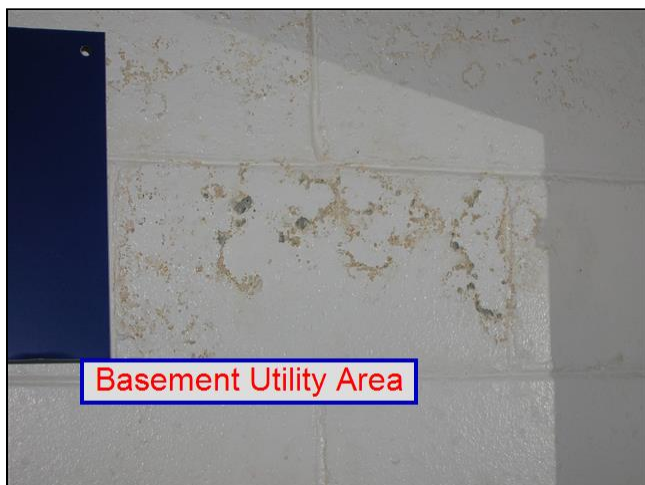
4.1 Item 1(Picture)

Walls in the basement show signs of past and current water intrusion. Recommend a qualified contractor in that area review and determine the best repair as needed.

Bedroom water by window show crack - needs to be fixed - recommend a qualified drywall contractor review and determine what the best options would be.

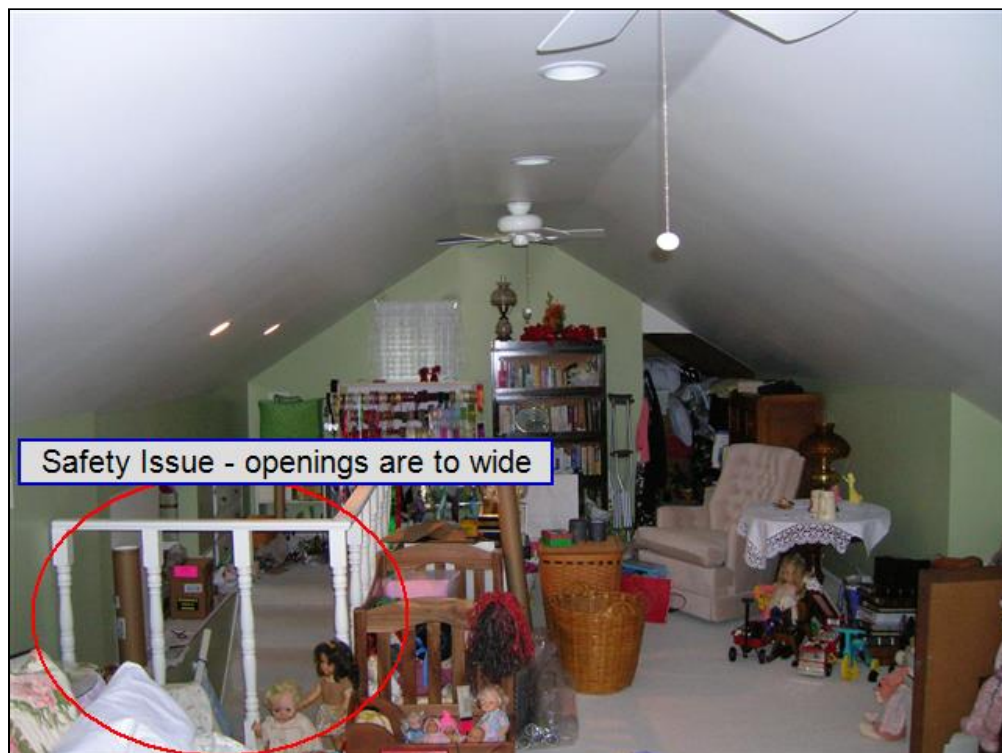
4.3 Item 1(Picture)

The guard rail on the second story stairs is more than 4 inches apart could allow an adult, child or pet to fall through. This is a safety issue and should be repaired or replaced.

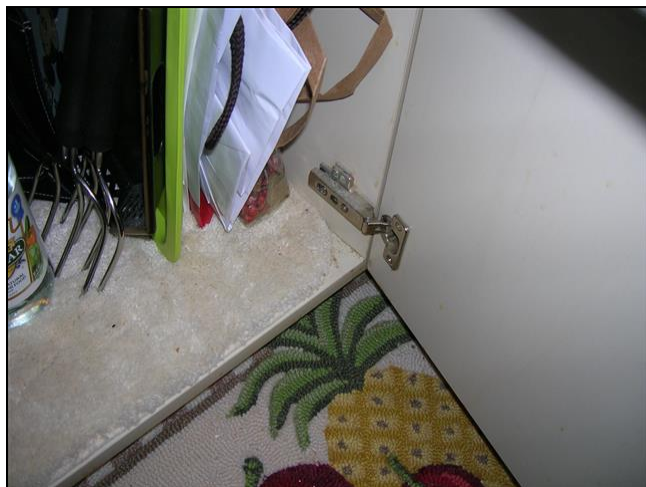
4.4 Item 1(Picture)

Hardware in kitchen just needs to be adjusted and tighten in a few locations. Picture shows under the sink on the right side, bracket is loose.

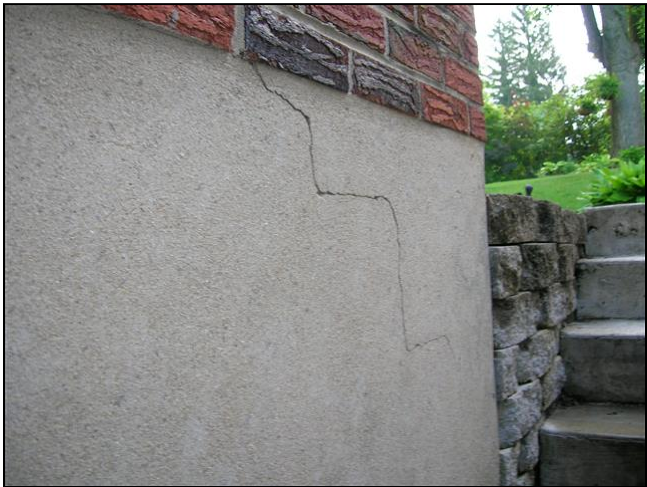
5.1 Item 1(Picture)

On the back porch on the left side there is a step crack running up through the brick. The crack should be sealed up to prevent moisture entering in from behind. This is not a safety issue but should be addressed by a qualified foundation contractor repair company with and the foundation should be monitored for any further movement.

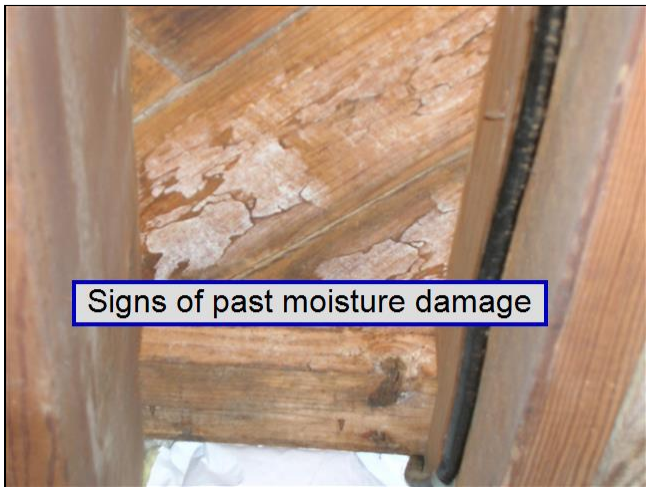
5.3 Item 1(Picture)

In the basement ceiling, there area areas of past water damage and past WDI damage. Recommend that this be monitored as needed.

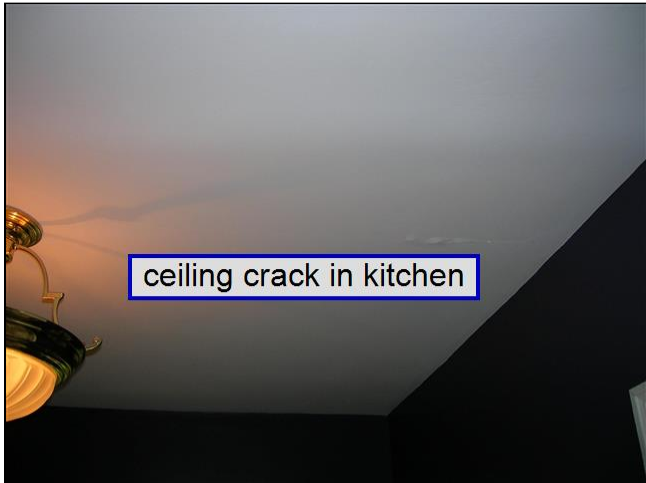
5.4 Item 1(Picture)

A number of closets were not accessible due to the amount of items in them. In the kitchen there is a sign of ceiling crack. Recommend repairs be made to the ceiling as desired by the owner.

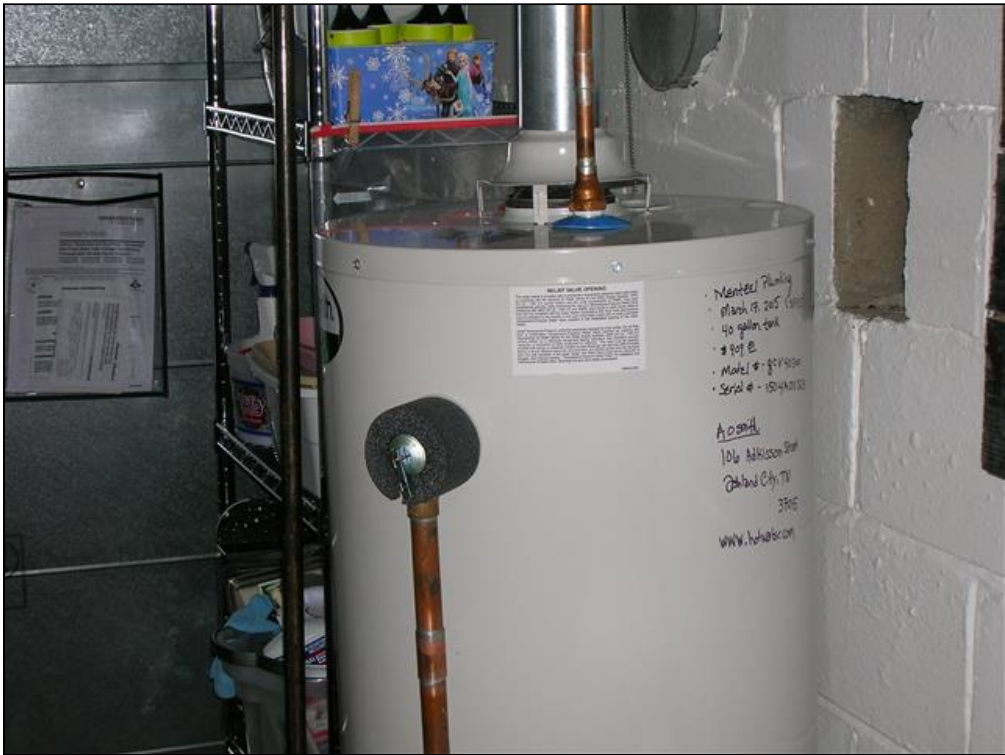
6.2 Item 1(Picture)

New Hot Water System installed without a water expansion tank. I would recommend an expansion tank be installed.

Main bathroom does not have an exhaust fan but does have an operative window with a ceiling fan.

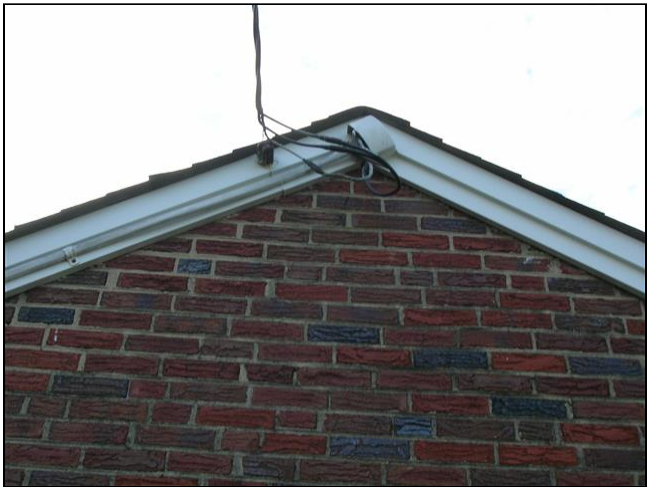
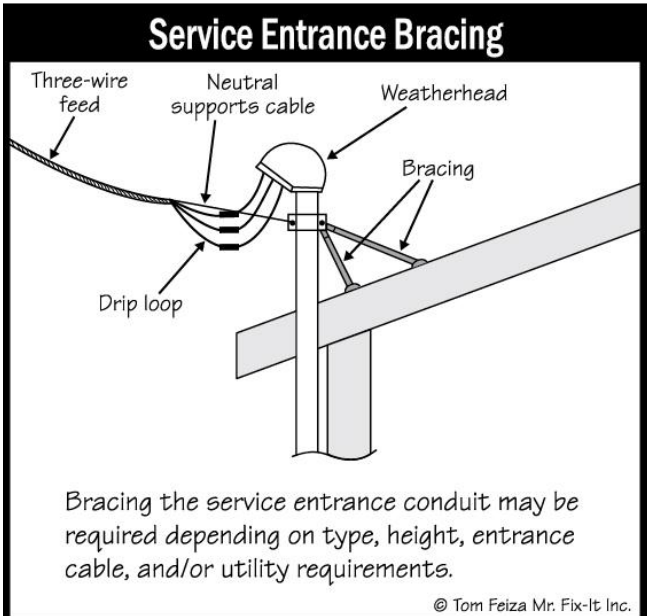
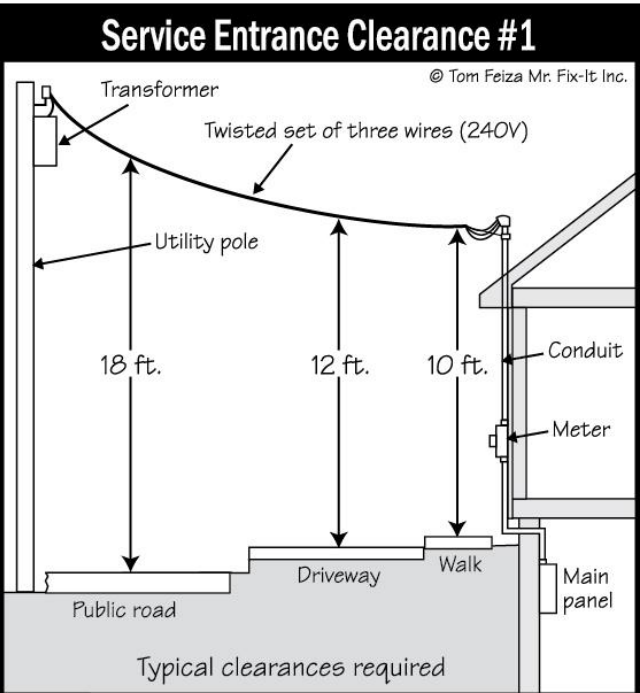
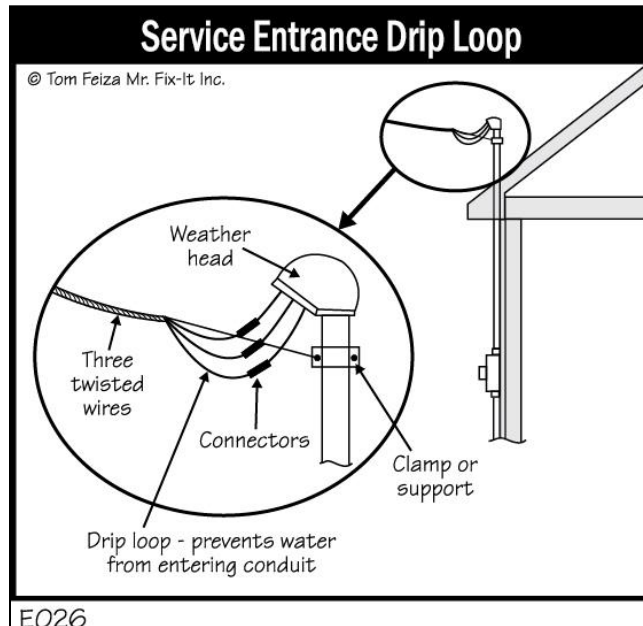
7.0 Item 1(Picture)

The service entrance conductors are prone to moisture and should be corrected. A qualified electrician should be contacted as well as the power company to do the repairs. Please see diagrams and drawings for the correct installation.

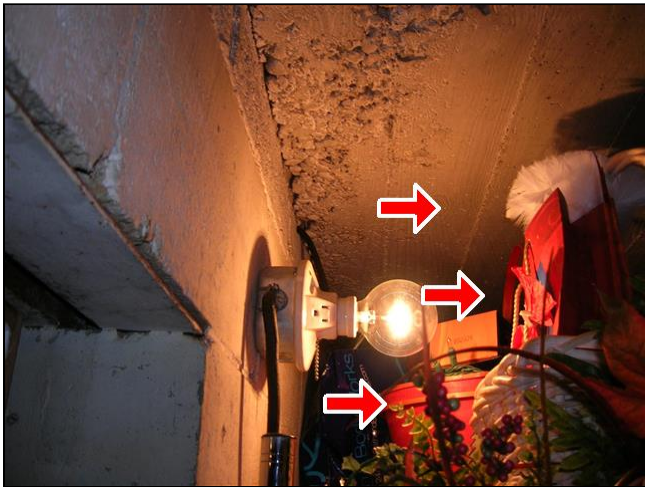
7.3 Item 1(Picture)

The garage door motor needs to have a plug installed. There is an extension cord to an an grounded light/ receptacle. This is a safety issue and a qualified electrical contractor should be contacted to correct this. A dedicated outlet should be installed for the operation of the motor.

The light in the storage area needs to be covered and the items need to be moved away - this is potentially fire hazard.

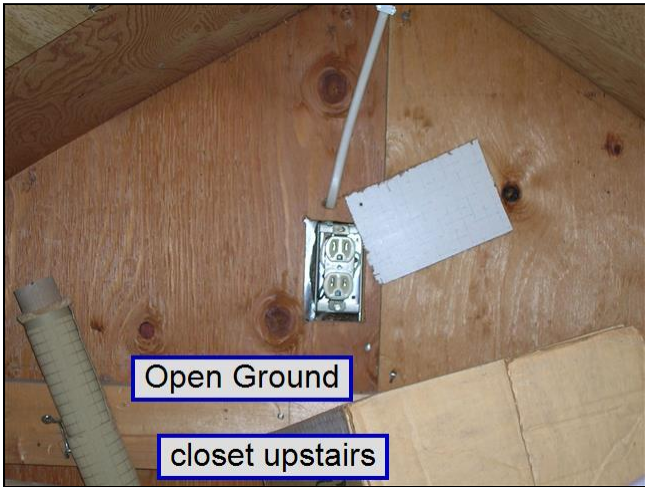
7.4 Item 1(Picture)

Found a number of open ground outlets throughout the home.

Closet upstairs outlet, hallway by main bedroom

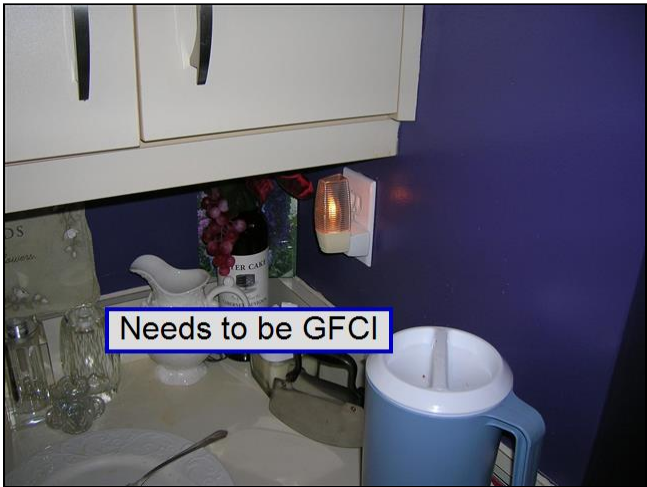
7.5 Item 1(Picture)

Numerous outlets in the home are not GFCI that should have been. Kitchen outlet is shown here.

NO Arc-Fault Circuit Interrupter located in any bedrooms of the home. Recommend they be installed by a qualified electrical contractor.

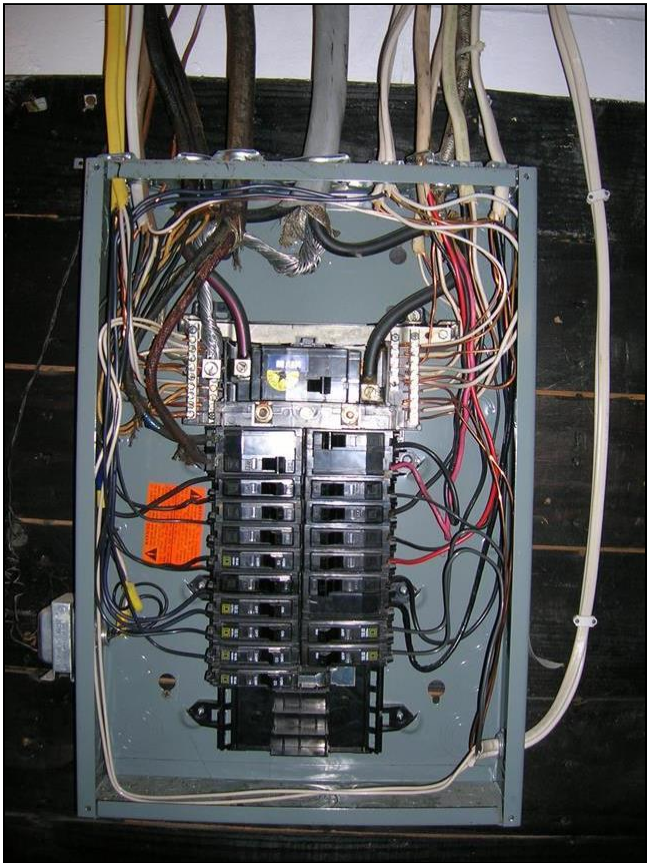
7.6 Item 1(Picture)

Basement Laundry Room Area 125 amp service

Panel does have lugs that have been double tapped and the connection on top where the wire comes through should be corrected also. Both these are safety issue and a qualified electrician should be contacted.

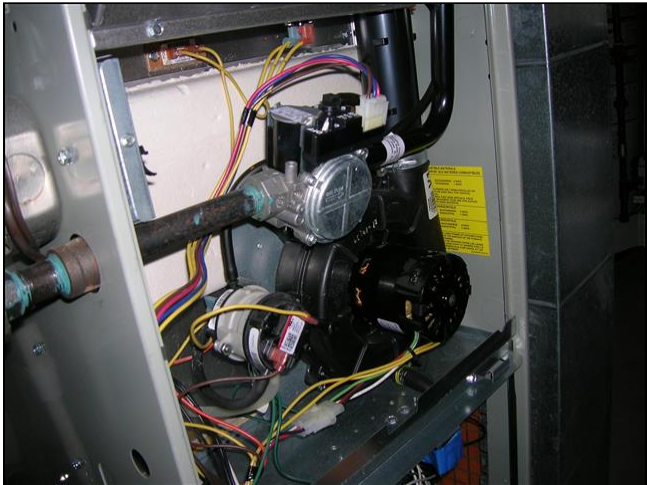
8.0 Item 1(Picture)

Unit is very new and running as it should.

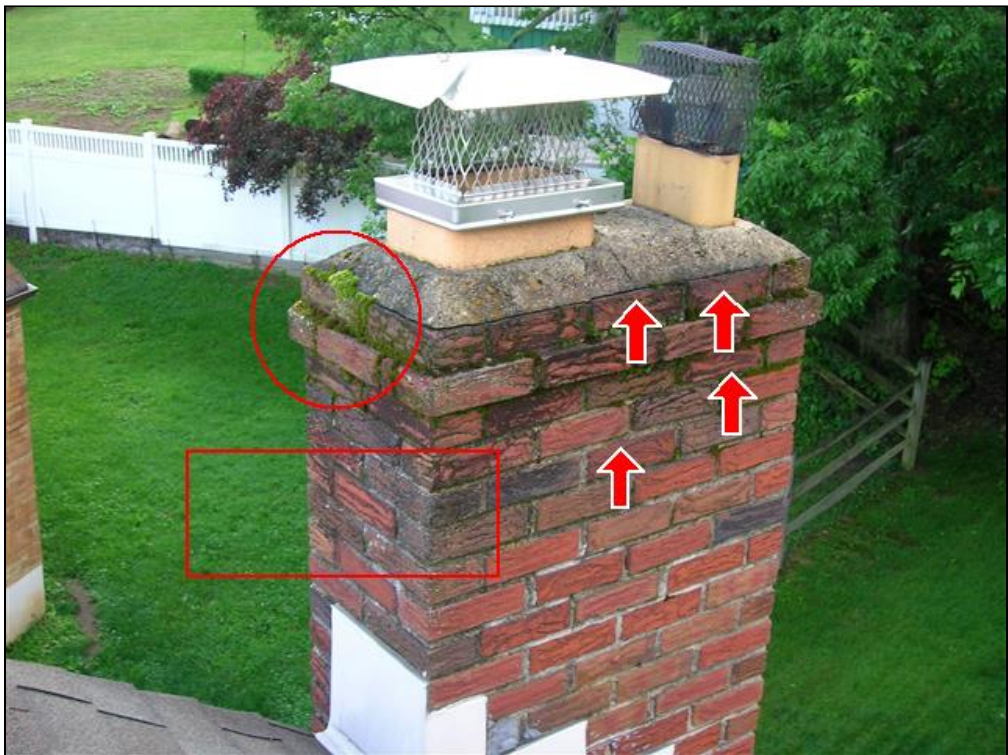
8.5 Item 1(Picture)

Needs inspected by a qualified chimney company. The chimney is in need of repair and shows signs of water damage and deterioration. A qualified masonry contractor should be contacted to repair as needed.

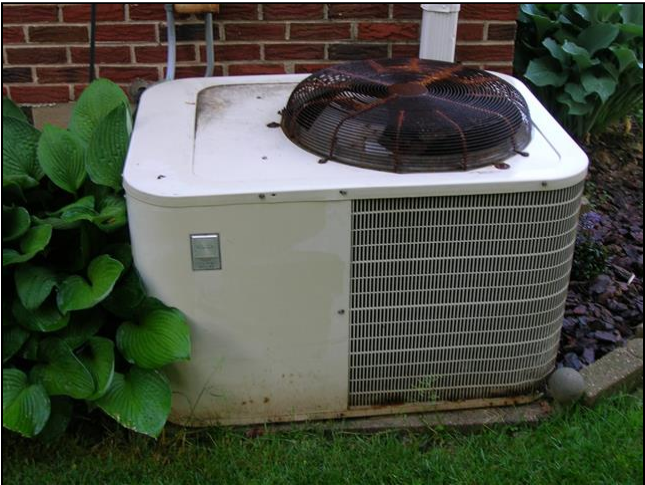
8.7 Item 1(Picture)

Unit is old and will have to be replaced in the near future. Recommend cutting away all vegetation and maintaining annual maintenance done on the HVAC.

Disconnect for HVAC unit compressor outside needs to be replaced. Recommend qualified electrician be contacted.

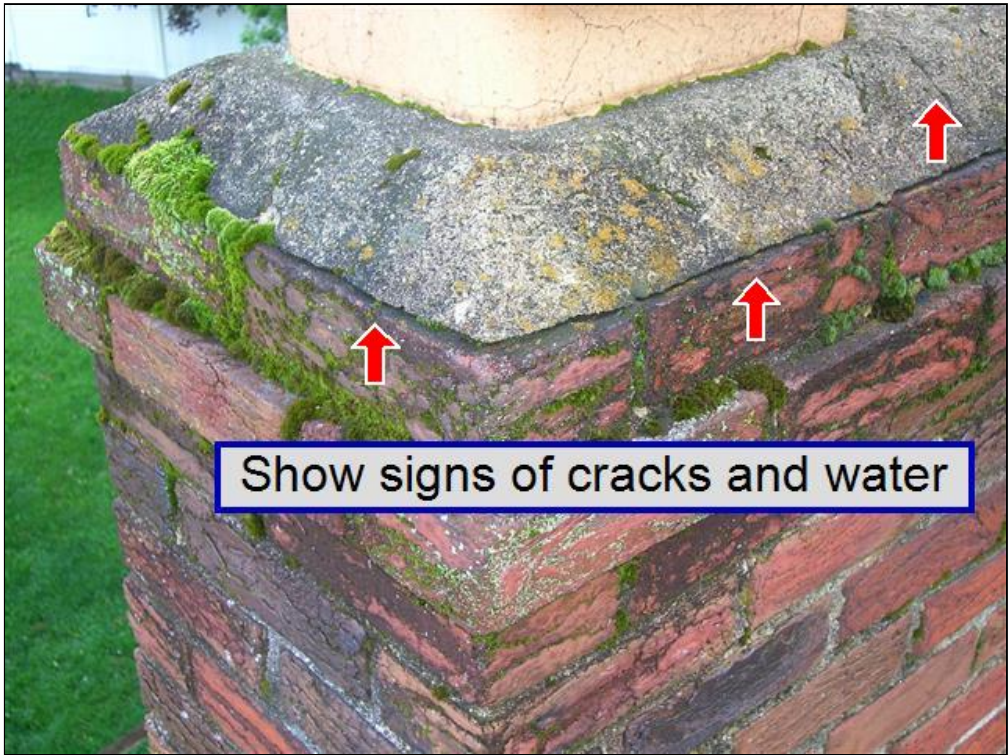
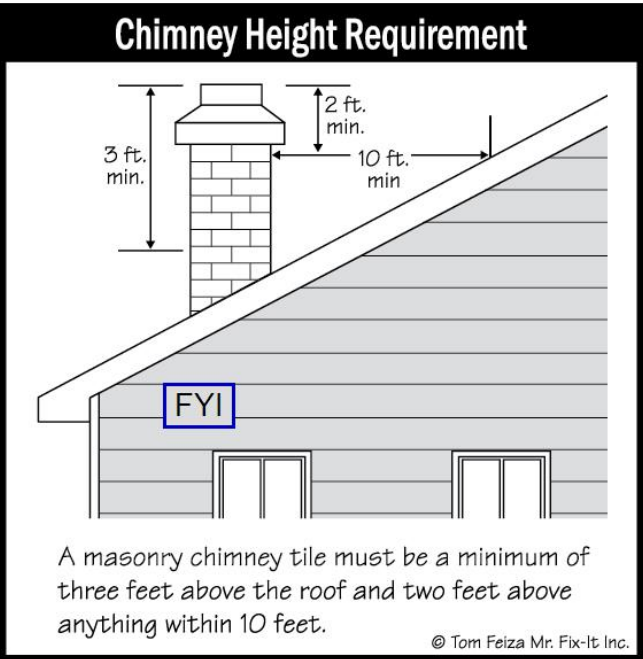
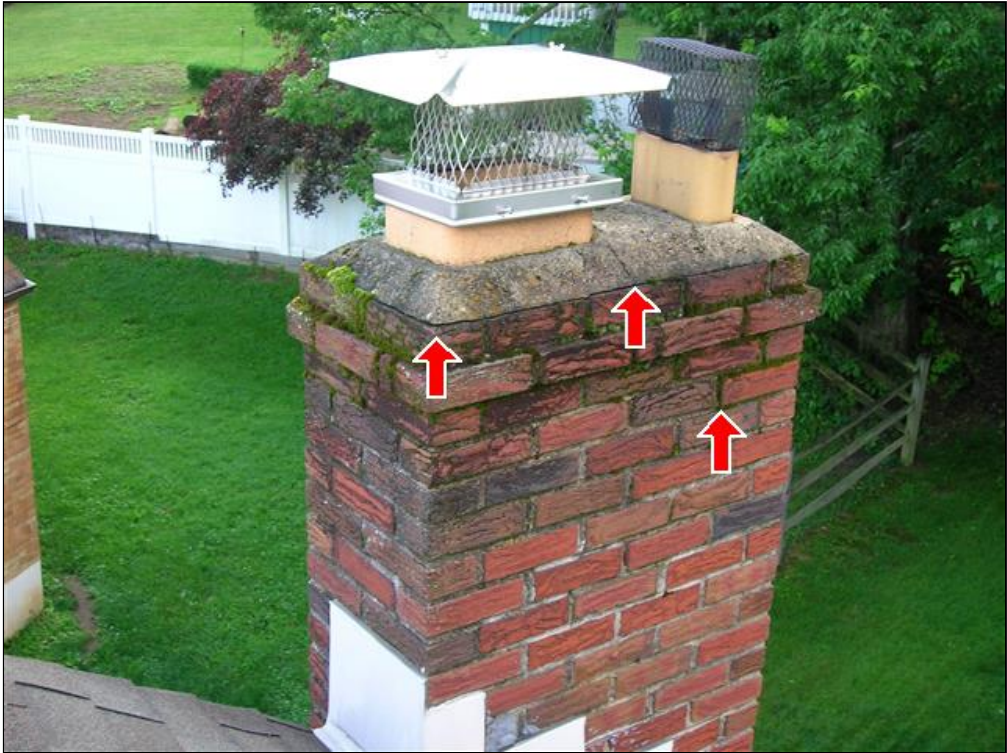
Item 3 - Item 1(Picture)

- 3. The plumbing vent on the back side of the roof is in need of repair. The chimney show signs of needed repair due to cracks in the cap and cracks in the brick. Recommend a masonry contractor review and inspect for repair needs.

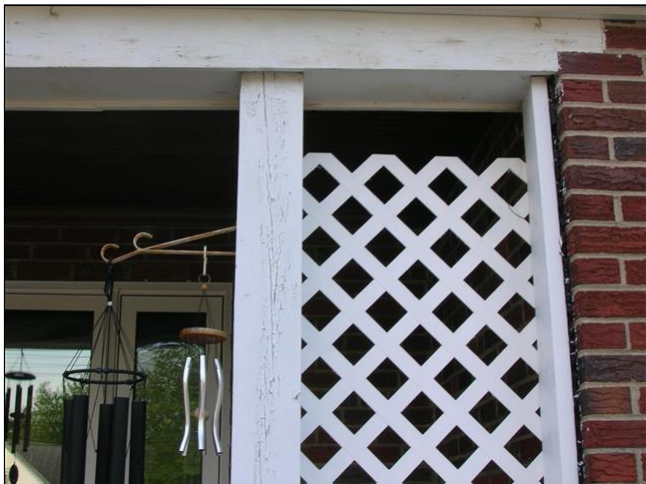
Item 4 - Item 1(Picture)

4.
- The trim of the home needs to be painted to keep any moisture out and help protect the home. The vinyl siding on the home is bleeding down onto the existing brick. Recommend that the siding and brick be cleaned.

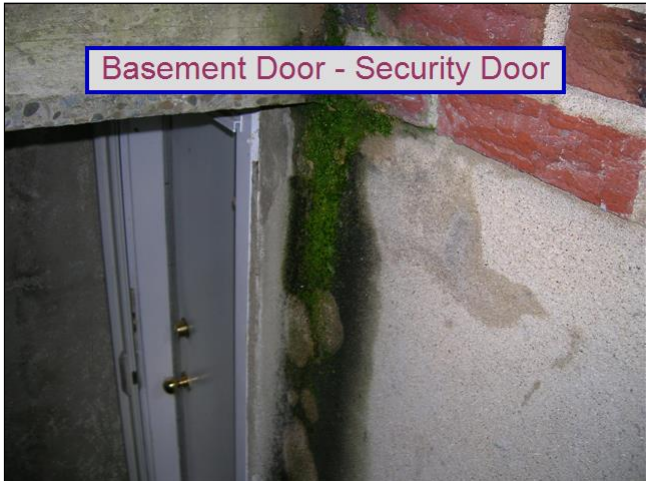
Item 5 - Item 1(Picture)

Front door is in good shape but could use new weather stripping. Rear entrance door is a solid security door but shows some signs of water intrusion. New weather stripping would also help here.

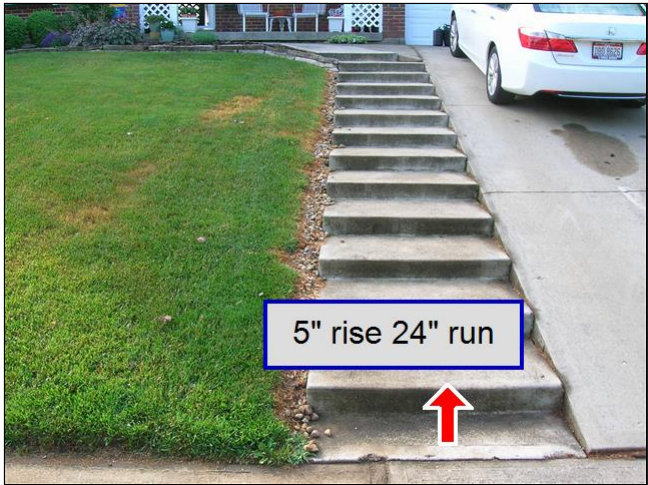
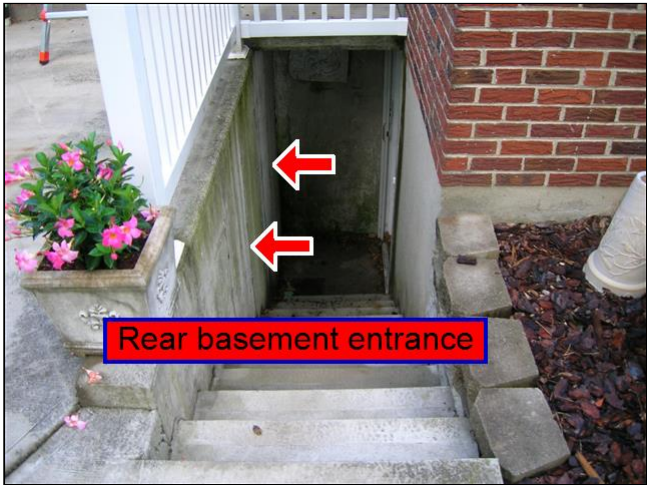
Item 6 - Item 1(Picture)

Front stairs from street to home have a short rise and long run. 5" rise and 24" run. Recommend hand rail be installed.

Rear entrance to home show signs of green algae and moisture on the concrete walls. Recommend that this area be cleaned.

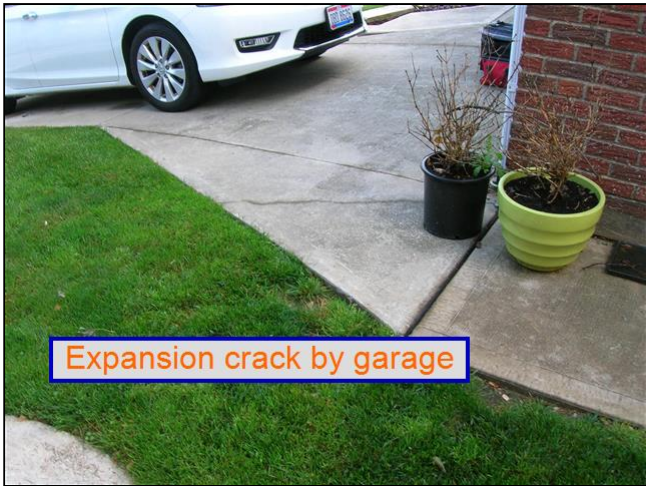
Item 7 - Item 4(Picture)

Mulch should be pulled away from the home. Vegetation has been well maintained. The vegetation around the gas meter needs to be cut away for better access. Driveway for the home is in good shape but the sidewalk is in need of replacement as desired.(See picture with box.)

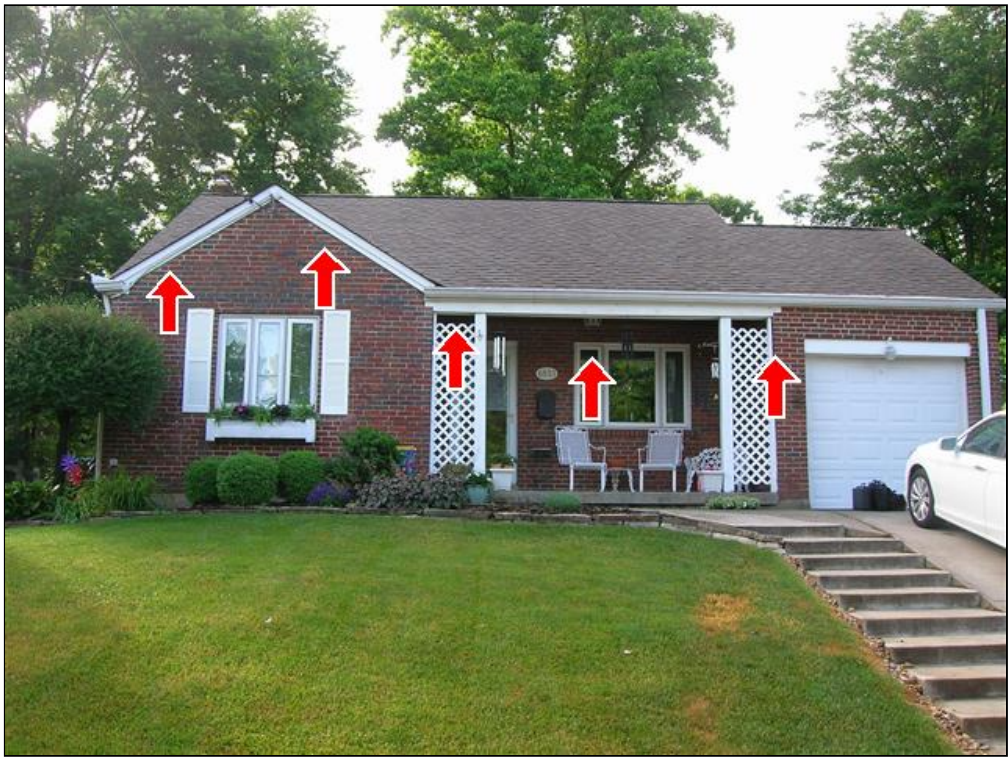
Item 8 - Item 1(Picture)

Eaves, Soffits and Fascias
Inspected, Clean, Repair or Replace
8. Exterior wood needs to be painted

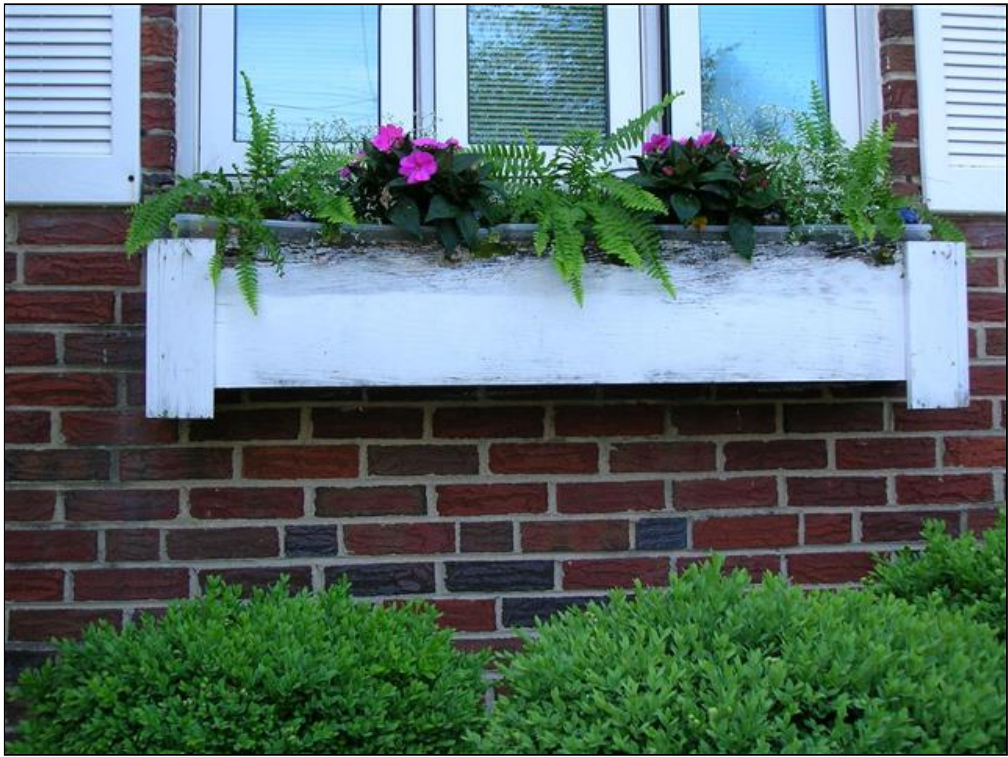
Item 9 - Item 1(Picture)

FYI: Flower Box needs to be replaced.

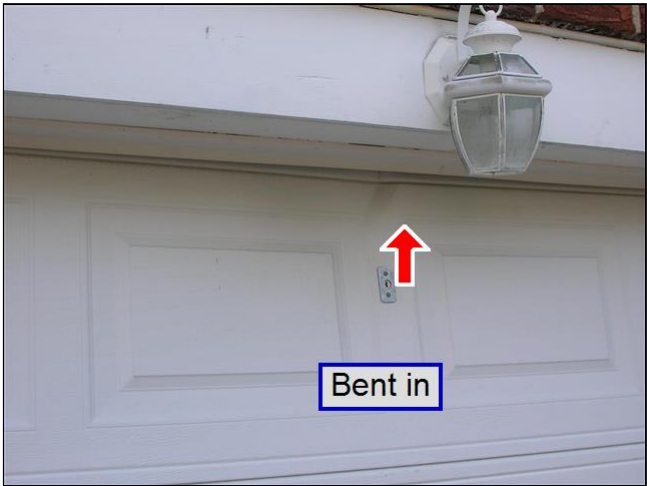
Item 11 - Item 1(Picture)

10. **Garage Ceilings**
 Inspected
11. **Garage Door (s)**
 Inspected, Clean, Repair or Replace
 Garage Door is bent. Recommend qualified contractor repair the door and the electrical issue should be addressed also.

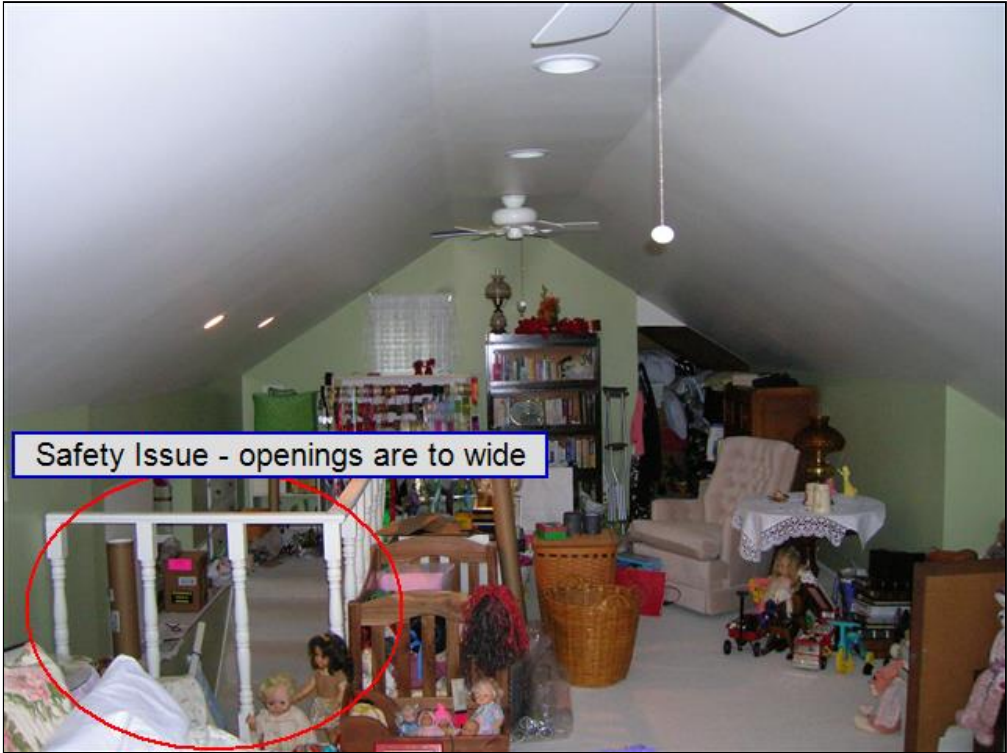
Item 13 - Item 1(Picture)

13.
- The guard rail on the second story stairs is more than 4 inches apart could allow an adult, child or pet to fall through. This is a safety issue and should be repaired or replaced.

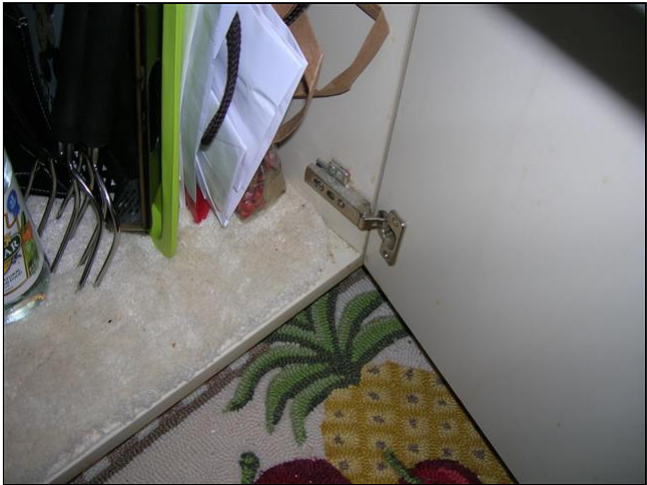
Item 14 - Item 1(Picture)

Hardware in kitchen just needs to be adjusted and tighten in a few locations. Picture shows under the sink on the right side, bracket is lose.

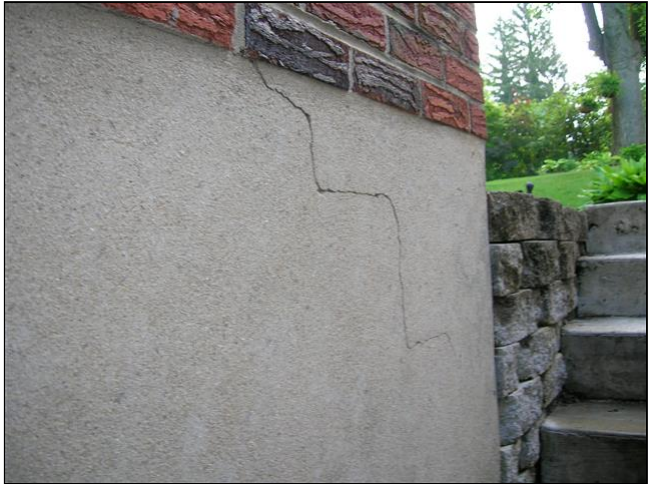
Item 17 - Item 1(Picture)

On the back porch on the left side there is a step crack running up through the brick. The crack should be sealed up to prevent moisture entering in from behind. This is not a safety issue but should be addressed by a qualified foundation contractor repair company with and the foundation should be monitored for any further movement.

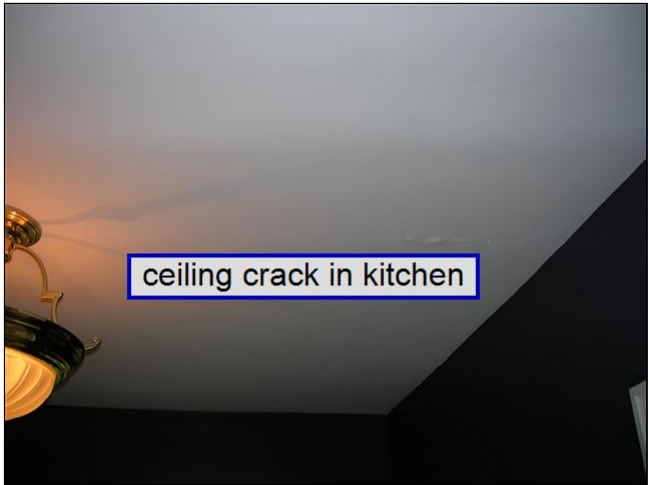
Item 19 - Item 1(Picture)

A number of closets were not accessible due to the amount of items in them. In the kitchen there is a sign of ceiling crack. Recommend repairs be made to the ceiling as desired by the owner.
