Inspection Report

Lower 80 Park Trail
Cincinnati Oh 45000

SAFEGUARD BUILDING INSPECTIONS, LLC

Date: 8/3/2015	Time: 08:30 AM	Report ID: 8-3-15 Lower 80 Park Trail
Property: Lower 80 Park Trail Cincinnati Oh 45000	Customer: Mr. Redtail Hawk	Real Estate Professional:

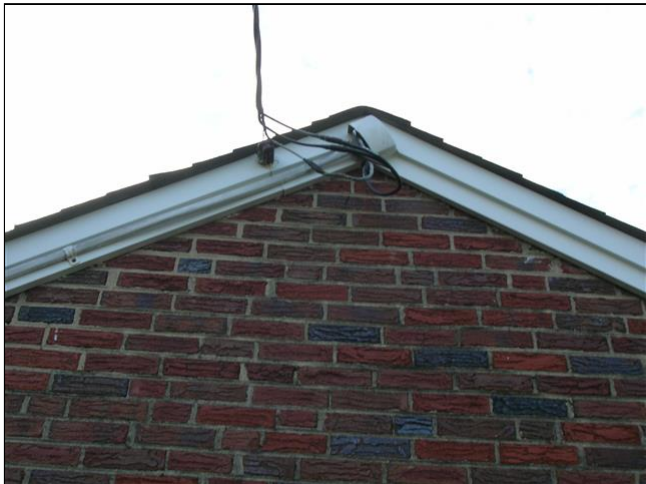
Item 22 - Item 1(Picture)

22.
- The service entrance conductors are prone to moisture and should be corrected. A qualified electrician should be contacted as well as the power company to do the repairs. Please see diagrams and drawings for the correct installation.

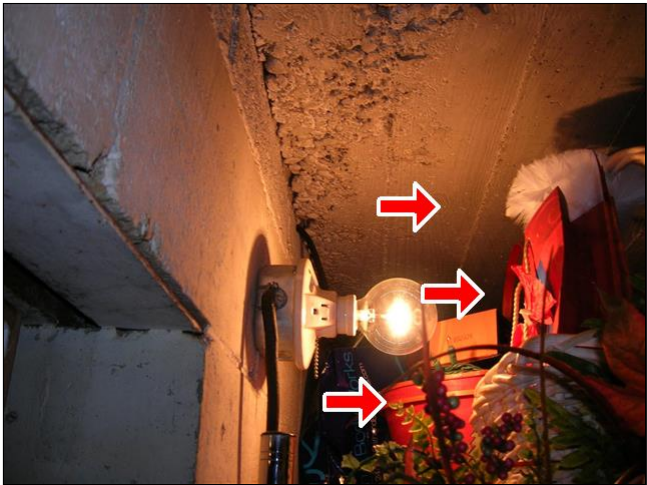
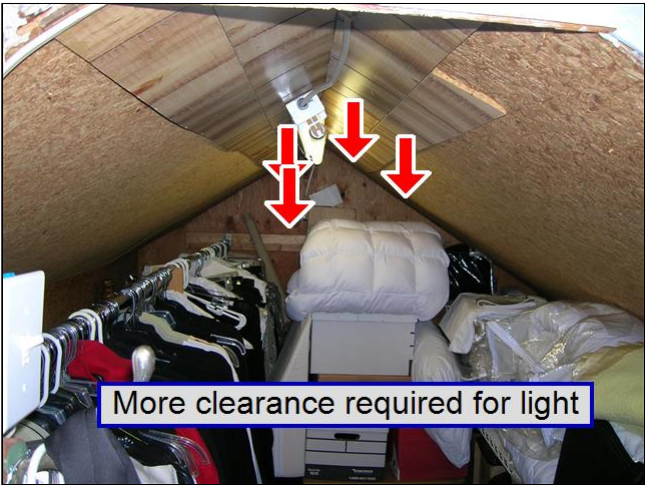
The light in the storage area needs to be covered and the items need to be moved away - this is potentially fire hazard.

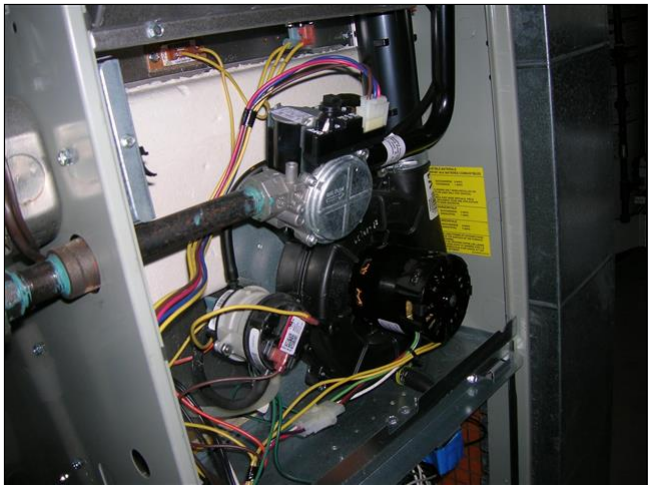
Item 28 - Item 1(Picture)

Unit is very new and running as it should.
